## Challenge

A two-stage vertical turbine booster pump seal failed within 2-3 days. The seal was changed out, and again it failed within the same 2 – 3 day time period. Clearly there was a problem, but no one knew why, and it was impossible to ‘see inside’ the seal to determine the root cause of the problem.

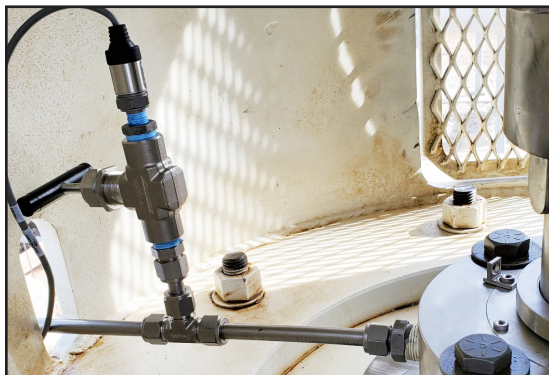
*P/T sensor in a two-stage vertical turbine booster pump.*

- A Chesterton Connect™ sensor was installed to monitor the process conditions causing premature seal failure. With the Chesterton Connect app, the user was able to chart the process pressure (decreasing) and temperature (increasing) while the pump was operating.
- Because of the Chesterton Connect data, critical operating changes were identified and the seal failure problem was fixed.

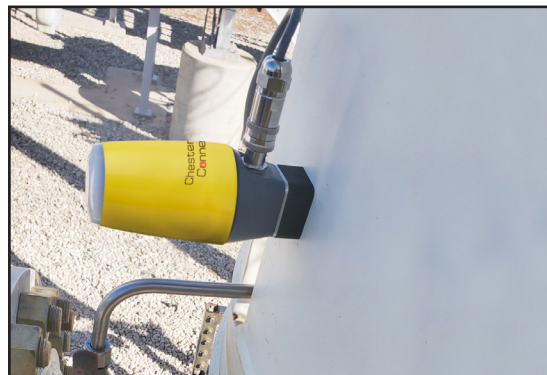
*Chesterton Connect monitors 24/7.*
