## Challenge

### Background

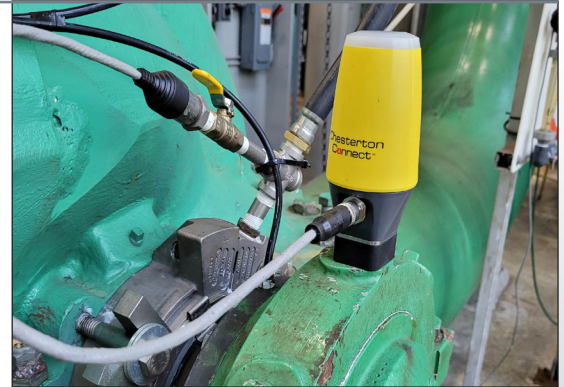
*Chesterton Connect sensor connected to split case pump.*

Two Chesterton Connect™ smart sensors were installed to monitor pump and mechanical seal conditions (vibration, process pressure, and temperature). Within days of being installed, the sensor recorded spikes in vibration and pressure fluctuations in the middle of the night while no one was at the plant.

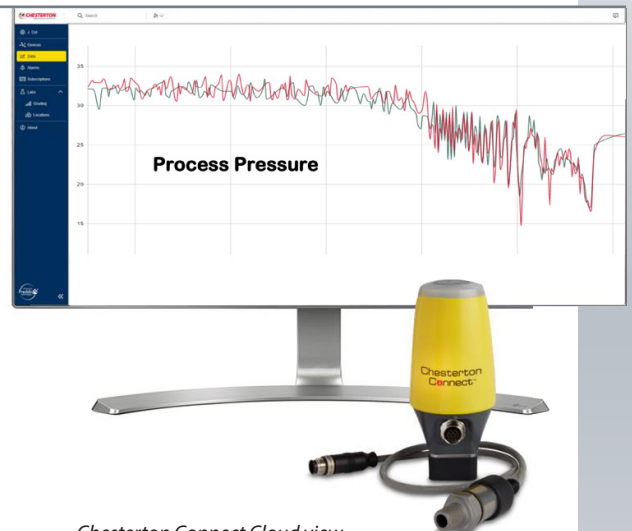
*Chesterton Connect Cloud view of pump's process pressure.*

Upon review of the Chesterton Connect Cloud graphed measurements, the incident was tied to a malfunctioning valve. The problem was addressed immediately, allowing the pump to return to normal operating conditions.
