# Sensor Identifies Cause of Costly Mechanical Seal Failure

Chemical Industry  
**Chesterton Connect**  
Case Study 004 Equipment Monitoring

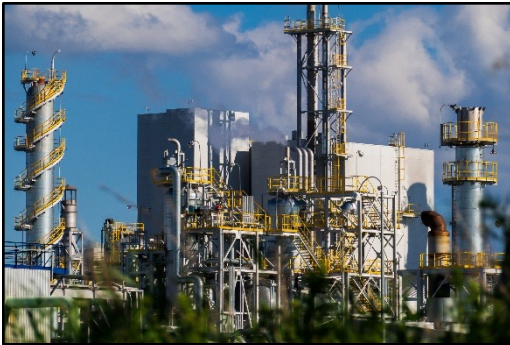
A chemical plant was experiencing an unusually high failure rate for single cartridge mechanical seals on a 65% Nitric Acid Transfer Pump application. At the time, the Mean Time Between Repair (MTBR) was only 1.2 months.

Our seal analysis revealed square, hardened O-Rings and seal faces with a heavy wear track. These symptoms typically point to dry running of the pump. However, the customer checked the operation of the system. All controls were in good working condition so dry running was very questionable. A specialist observed the installation of the seal and found that the customer was doing it correctly. There were no noticeable issues with the operation of the pump.

*The pump seal failure occurred nearly every month.*

Within a few days, the team gathered enough data from Connect to identify negative pressure in the seal chamber when the pump was running. In turn, this pressure caused the mechanical seal to show classic dry run symptoms...square, hardened O-Rings with heavy seal face wear tracks.

After conducting a system audit, the customer was able to throttle back a valve to ensure proper flow from the pump. The pump and mechanical seal are now running properly and the projected MTBR has improved to more than 24 months!

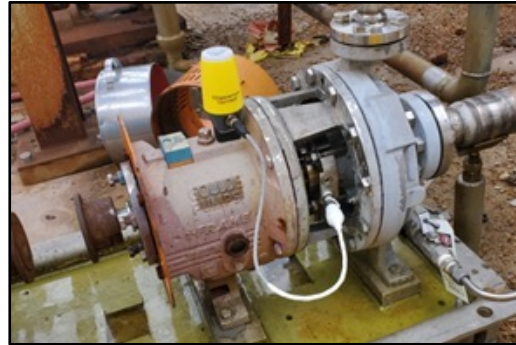
The Chesterton sealing specialist recommended installation of a **Chesterton Connect™** sensor, which safely and conveniently monitors operating conditions of many types of process equipment. Connect uses Bluetooth technology and offers a solid design that withstand harsh environments.

*Chesterton Connect installed on the pump.*
